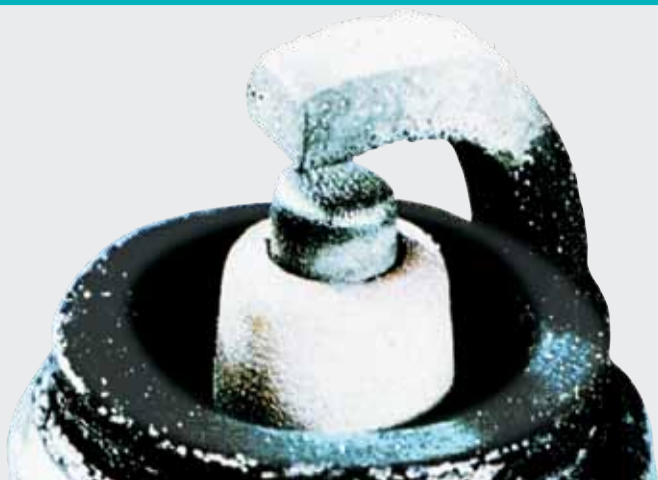
Normal condition

Normal condition of a functioning spark plug

Insulator nose from gray-white/gray-yellow to fawn brown color.

Engine is OK. Heat range correctly selected. Mixture setting and ignition timing OK, no misfiring, cold starting device functioning. No residue from fuel additives containing lead or alloying constituents from engine oil. No thermal overload.

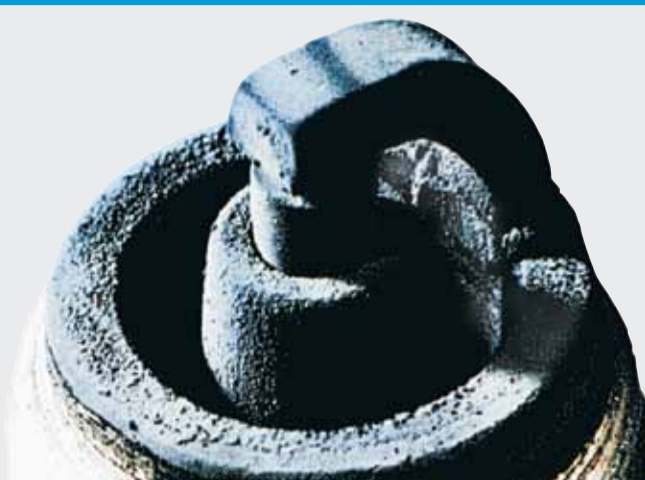
Carbon-fouled

Insulator nose, electrodes and spark-plug shell covered with velvet-like dull black soot deposits.

Cause: Incorrect mixture setting (carburetor, injection): Mixture too rich, air cleaner severely fouled, automatic choke not OK or manual choke actuated too long, predominantly short distance driving, spark plug too cold, heat range code number too low.

Effect: Misfiring, poor cold starting performance.
Remedy: Set mixture and starting device correctly, check air cleaner.

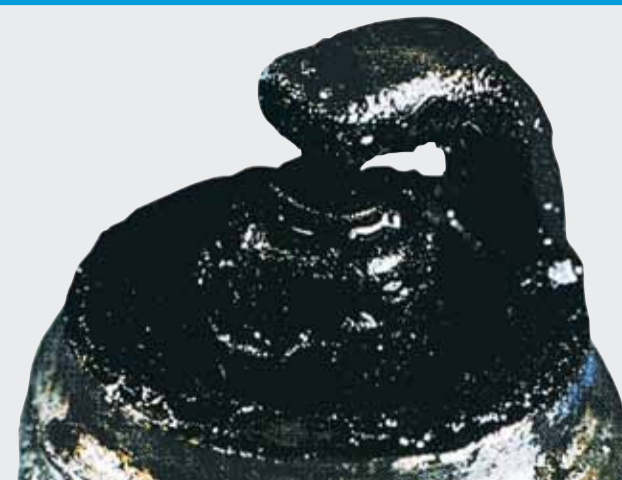
Oil-fouled

Insulator nose, electrodes and spark-plug shell covered with shiny soot or carbon deposits.

Cause: Too much oil in combustion chamber. Oil level too high, heavily worn piston rings, cylinders and valve guides. In two-stroke gasoline engines, too much oil in mixture.

Effect: Misfiring, poor starting performance.
Remedy: Overhaul engine, correct fuel/oil mixture, new spark plugs.

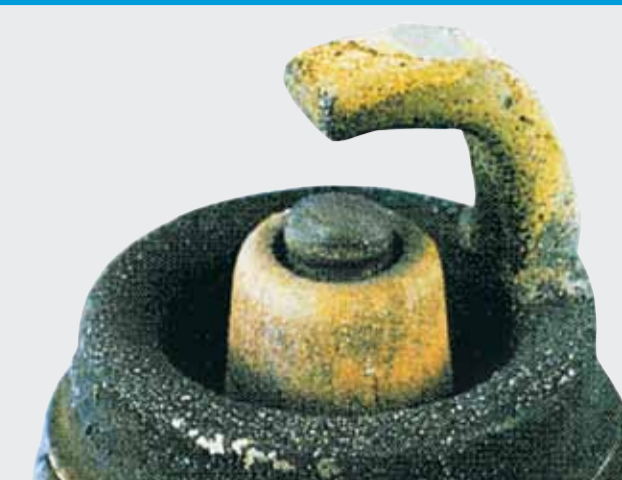
Severe center electrode wear

High material abrasion at the center electrode due to wear

Cause: Spark-plug replacement interval not complied with.
Effect: Misfiring, particularly during acceleration (ignition voltage no longer sufficient for large electrode gap). Poor starting performance.
Remedy: New spark plugs.

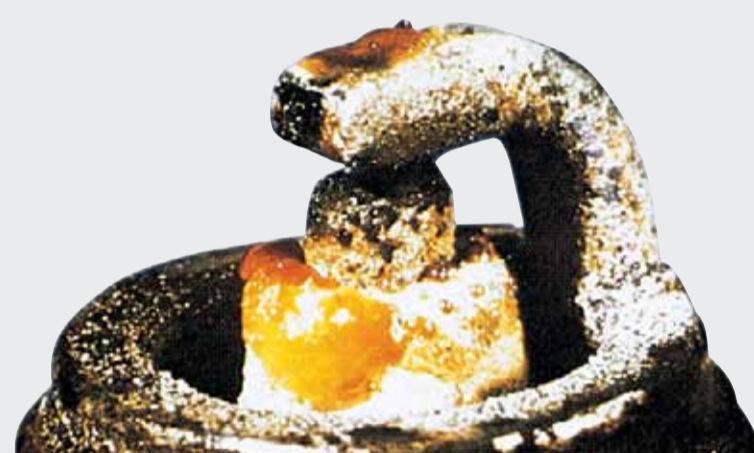
Heavy lead deposits

In places, thick brownish yellow glaze on insulator nose which may also have a greenish tinge.

Cause: Fuel additives containing lead. Glaze develops under heavy engine load after lengthy part load operation.

Effect: With heavy loading, coating becomes conductive and causes misfiring.

Remedy: New spark plugs, cleaning has no effect.

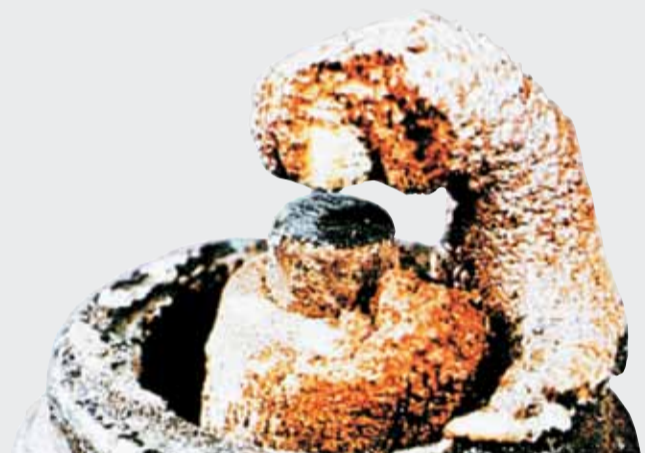
Ash-fouling

Thick ash coating from oil and fuel additives on insulator nose, in scavenging area (annular orifice) and on ground electrode. Loose to cinder-like structure.

Cause: Alloying constituents, particularly from oil, may deposit such ash in the combustion chamber and on the spark-plug face.

Effect: Can lead to auto-ignition with loss of power and engine damage.

Remedy: Check engine, New spark plugs, possibly use different oil.

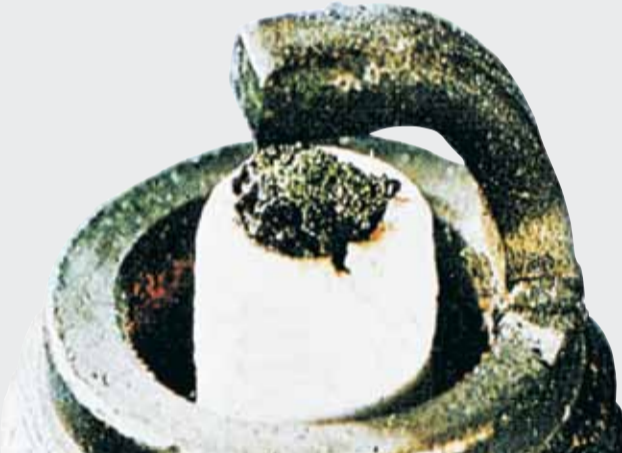
Partially melted center electrode

Center electrode partially melted, blistered, spongy, soft insulator nose tip.

Cause: Thermal overload due to auto-ignition, e.g. excessively advanced ignition timing, combustion residue in combustion chamber, defective valves, defective ignition distributor and poor fuel grade. Heat range possibly too low.

Effect: Misfiring, loss of power (engine damage).
Remedy: Check engine, ignition and mixture formation. New spark plugs with correct heat range.

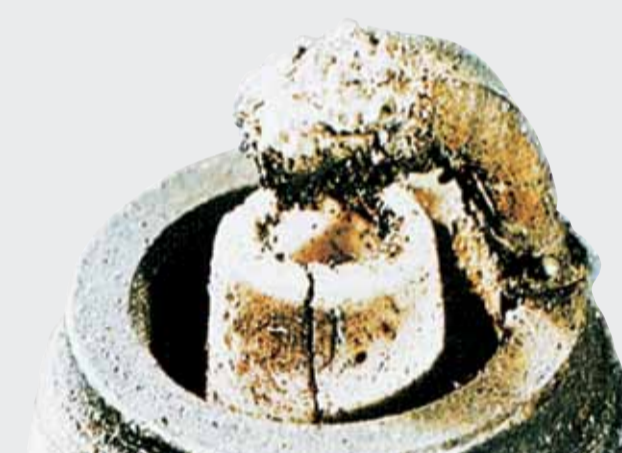
Melted center electrode

Center electrode melted, ground electrode also severely corroded.

Cause: Thermal overload due to auto-ignition, e.g. excessively advanced ignition timing, combustion residue in combustion chamber, defective valves, defective ignition distributor and poor fuel grade.

Effect: Misfiring, loss of power, possibly engine damage. Overheated center electrode may cause insulator nose to crack.

Remedy: Check engine, ignition and mixture formation. New spark plugs.

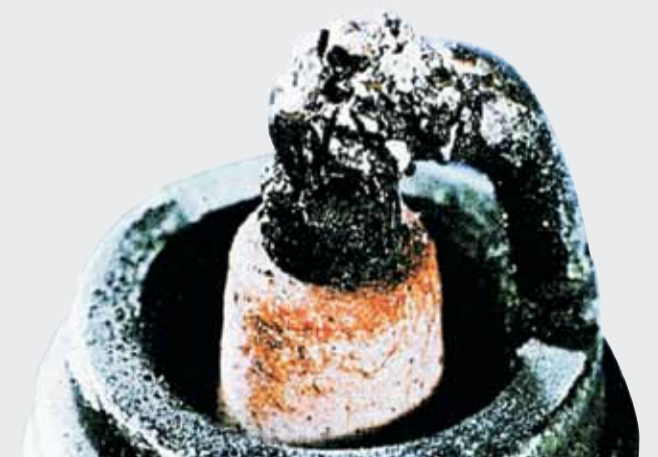
Melted electrodes

Cauliflower-like appearance of electrodes. Possibly precipitation of material not originating from the spark plug.

Cause: Thermal overload due to auto-ignition, e.g. excessively advanced ignition timing, combustion residues in combustion chamber, defective valves, defective ignition distributor and poor fuel grade.

Effect: Loss of power.

Remedy: Check engine, ignition and mixture formation. New spark plugs.

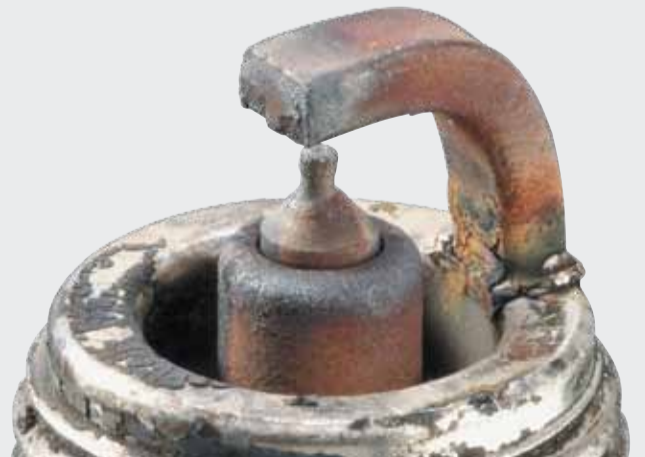
Ferrocene

Insulator nose, electrodes and part of the spark plug housing coated with red-orange adherent deposits.

Cause: Fuel additive containing iron. The deposits occur after a few thousand kilometers in normal operation.

Effect: The coating containing iron is electrically conductive and causes misfiring.

Remedy: New spark plugs, cleaning has no effect.

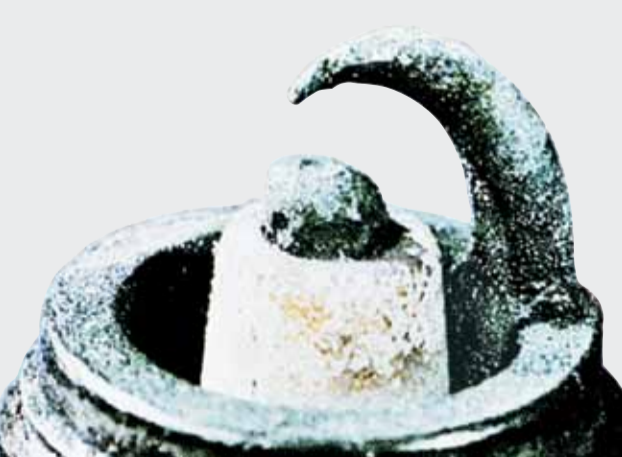
Severe ground electrode wear

High material abrasion at the ground electrode due to wear

Cause: Aggressive fuel and oil additives. Unfavorable flow conditions in combustion chamber, possibly due to deposits, engine knocking. No thermal overload.

Effect: Misfiring, particularly during acceleration (ignition voltage no longer sufficient for large electrode gap). Poor starting performance.

Remedy: New spark plugs.

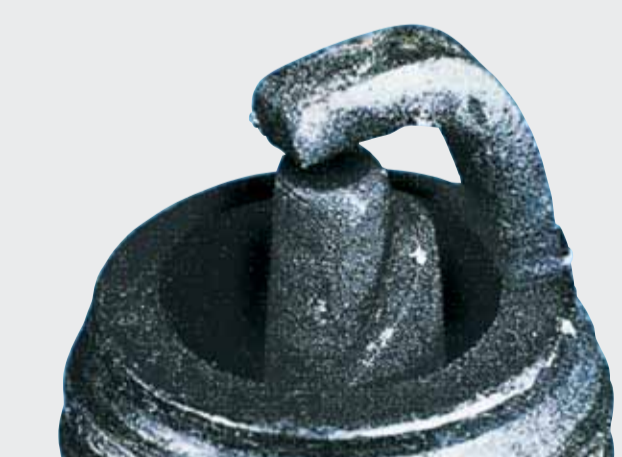
Cracking of insulator nose

Cause: Mechanical damage due to impact, dropping or pressure on the center electrode resulting from incorrect handling. In marginal cases – especially after excessively long use – the insulator nose may crack due to deposits between the center electrode and insulator nose, and due to corrosion of the center electrode.

Effect: Misfiring, sparkover at points not reliably supplied with fresh mixture.
Remedy: New spark plugs.
